# Manhole Inspection Summary

Manhole # **S15C\_\_035MH**

**Location** Address: **REAR OF 617 GLENOLDEN AVE** Cross Street: **EDMONSON AVE**

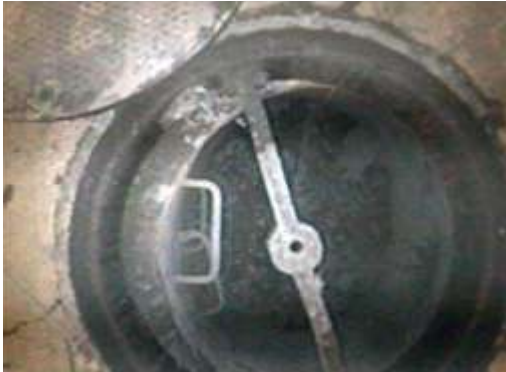
Defect 1

frame offset and corroded step

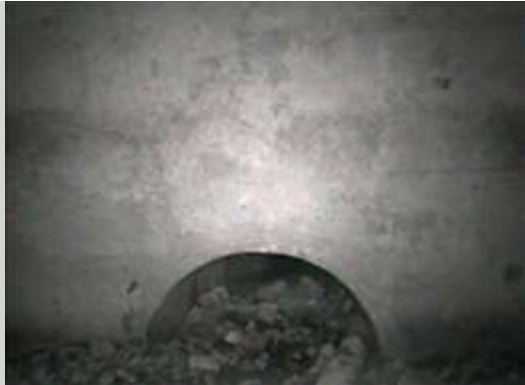
12 O'Clock Outflow

8 in. Circular Gravity Sewer  
Pipe Out @ 12 O'Clock

Deposits: ☐ None ☒ **Mud** ☐ Sludge ☒ **Debris** ☐ Grease

Silt Depth: **4** (in.) Deposits Extent: **Medium**
